# Case Study to trial different management treatments to mitigate tunnel erosion

South Gippsland 2017

## Case Study to trial different management treatments to mitigate tunnel erosion

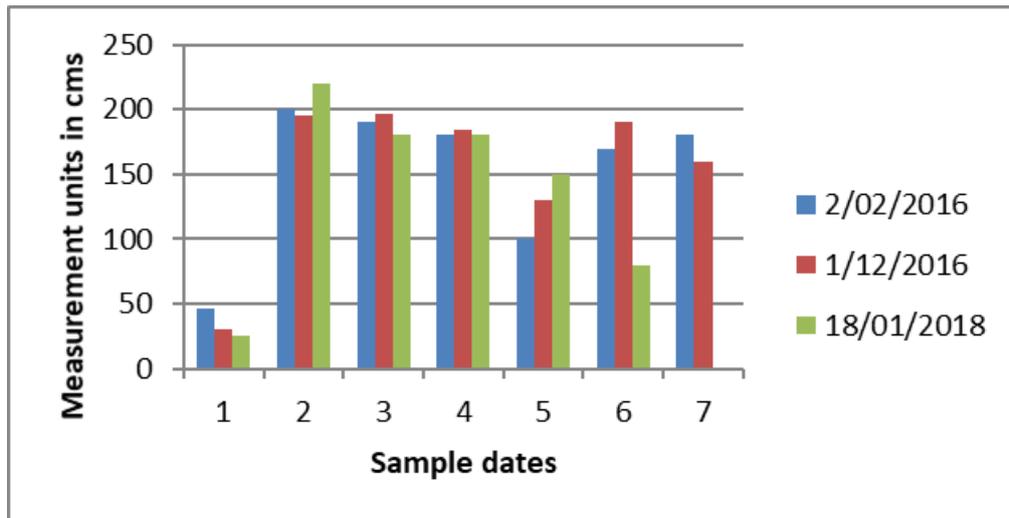
Diagram 2 Site A - Fixed Point 1 – Measurements 1-7

**Site A, Fixed Point 1:** This was located towards the top end of the gully. This is the longest of the three gullies and was fenced. The base was lined with rock and revegetated with trees and shrubs. There appears to be a decreasing trend for gully width at this point between February 2016 and January 2017 for the first four measurements. Gully depth at deepest point showed an increase for 100cm to 150cm, however gully depth 1.5m above and below the deepest point showed a decrease between February 2016 and January 2018.

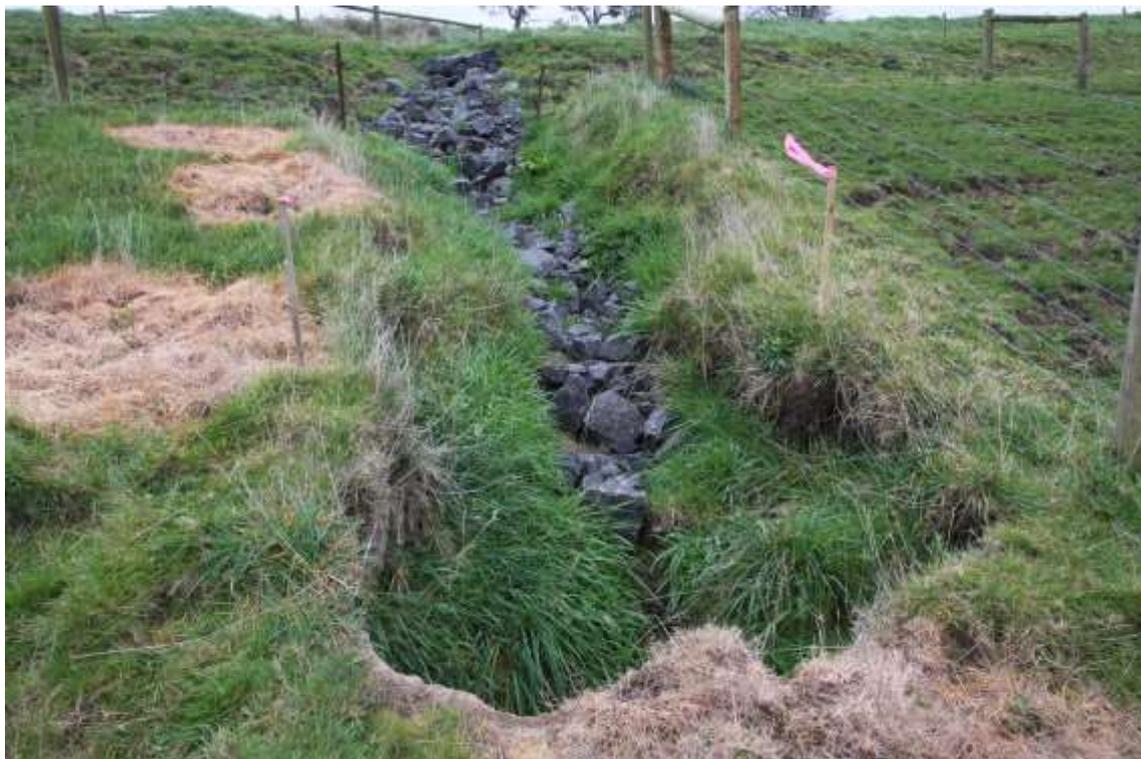
Photo 1 - Site A: August 2015: Top of gully looking upslope (Fixed Point 1)

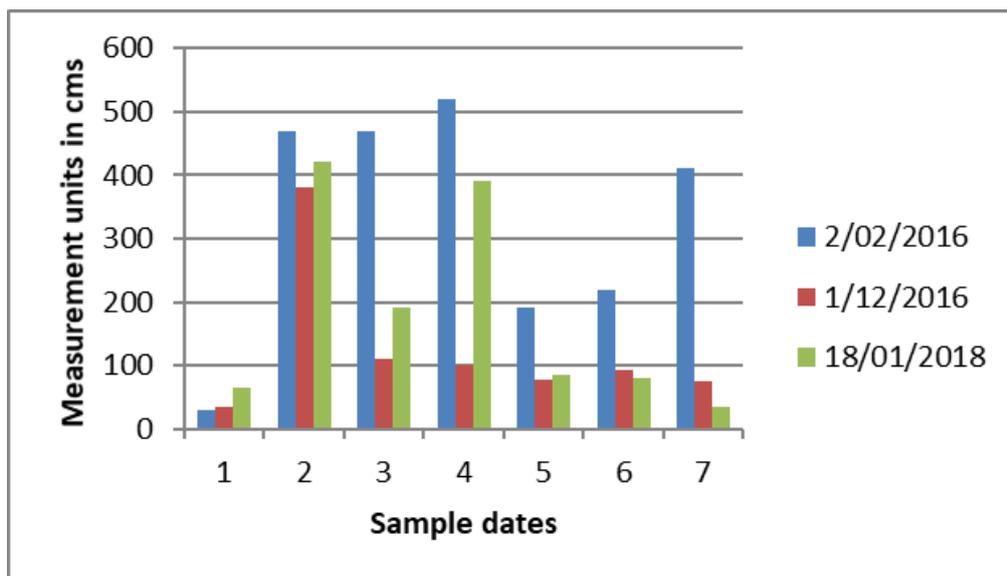
**Diagram 4 Site A - Fixed Point 2 – Measurements 1 -7**

**Site A, Fixed Point 2:** This was located approximately half way down the gully. There didn't appear to be much variation for measurements 1 and 2, however there was significant variation for measurements 3 and 4. Overall measurements decreased between February 2016 and January 2018 which would appear to indicate that gully depth and width was decreasing at this point.

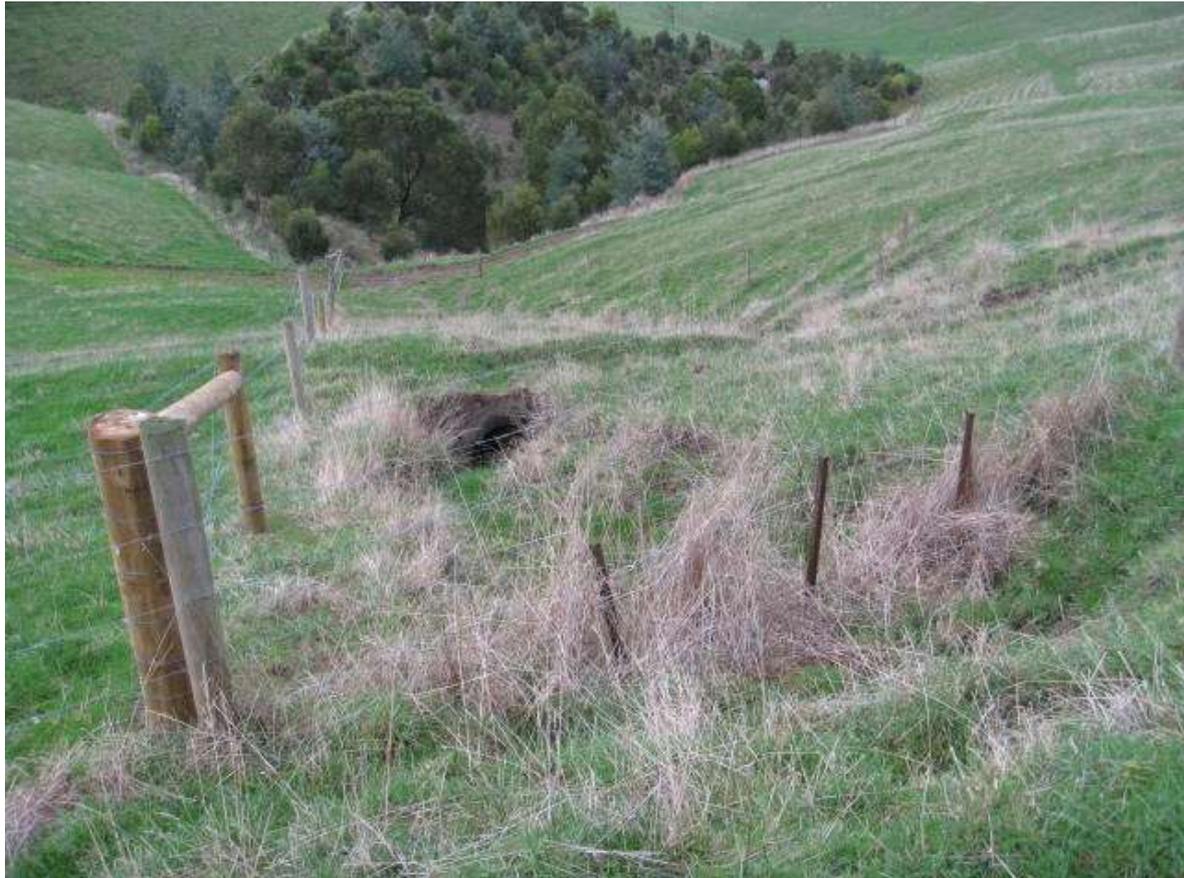
**Photo 2** - Site A: May 2014 - Top of tunnel looking downslope

**Site A:** Clean out side drain on laneway above to divert water (surface runoff) to a culvert located 80 metres away to redirect surface water. Use stones at the base of the culvert to intercept and disperse water. Line the gully with erosion matting and several round bales on upper slope to trap sediment, then fence and revegetate. This is the major gully on the property which has developed from what was originally a tunnel and has since collapsed.

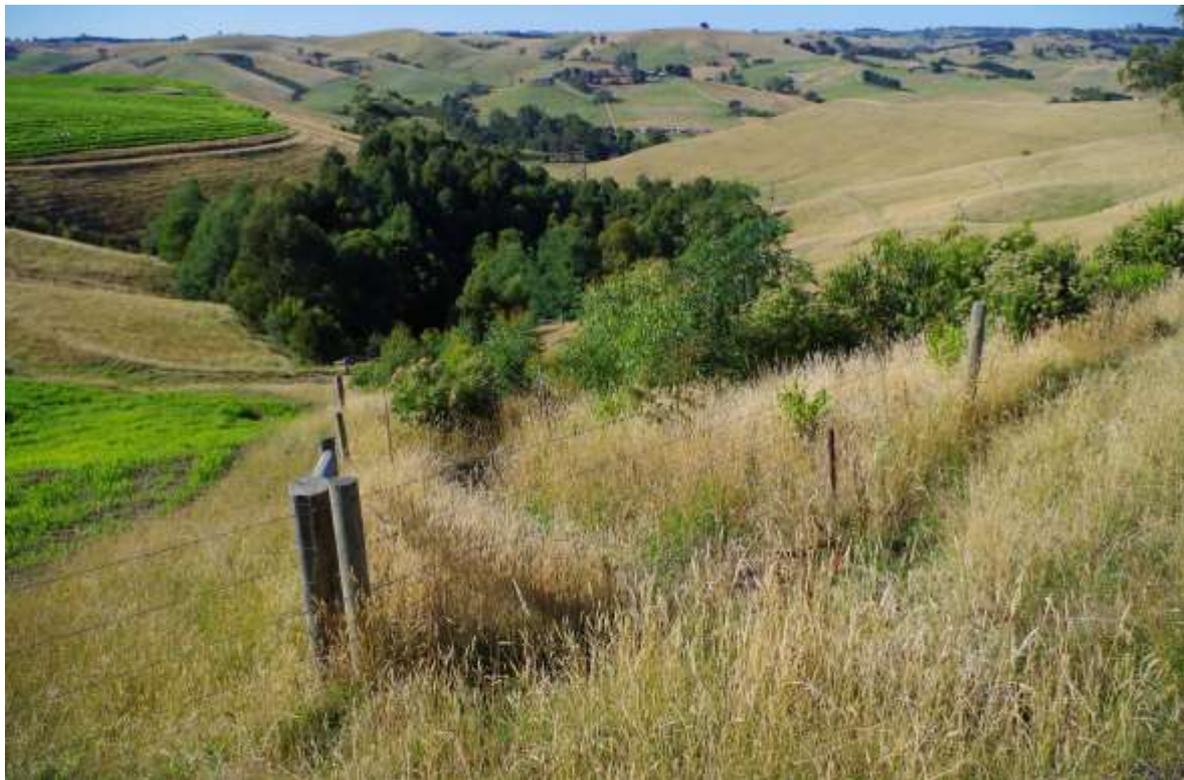
**Photo 3** - Site A: January 2018: Post fencing, rock stabilisation and revegetation

**For Site A** there is evidence to suggest that fencing the gully from livestock and slowing down the flow of water has largely arrested further widening of this gully at the three fixed monitoring points measured. Most recent observations at fixed point 2 (January 2018) showed evidence that rabbits or other digging animals had accessed the site and may account for some slumping on gully edges above and below the widest point. There was an increase in total erosion length for fixed points 1 and 2 but this had decreased for fixed point 3. This would appear to indicate that there was further development in length of the gully but not width. There was an overall decrease in tunnel depth at the first two fixed points which could be due to a deposition of material, but an increase in depth towards the bottom of the gully at fixed point 3.

**Fenced Site A:** The diversion of surface runoff, fencing from livestock and revegetation with deep rooted species e.g. trees and shrubs would appear to have arrested further widening of this gully at the three fixed monitoring points measured. Most recent observations at fixed point 2 (January 2018) showed evidence that rabbits or other digging animals had accessed the site and may account for some slumping on gully edges.

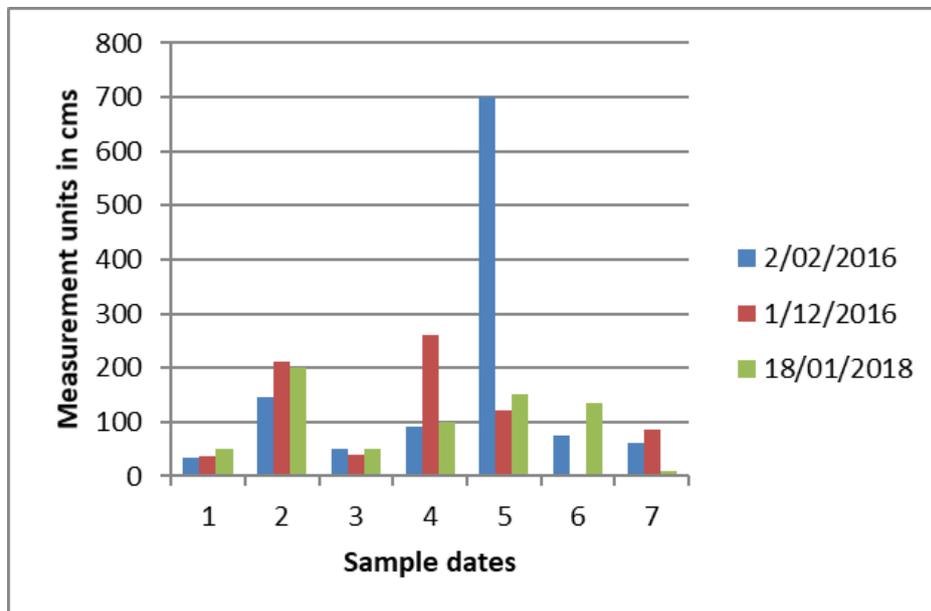
**Diagram 5 Site A - Fixed Point 3 – Measurements 1-7**

**Site A, Fixed Point 3:** This was located towards the end of the gully about three quarters of the way down the slope. The data appears to show some minor increase in both tunnel width and depth at this point with the exception of measurement 5 which was measured initially at 700cm in Feb 2016 but decreased markedly for the next two measurement dates.

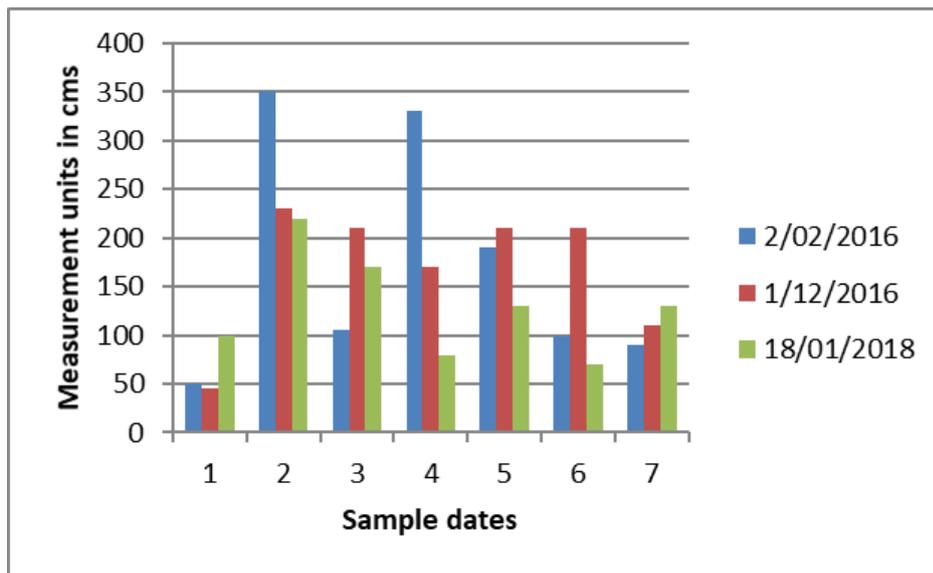
**Diagram 5 Site B – Fixed Point 1 - Measurements 1-7**

**Site B:** Due to its shorter length only one fixed point was measured for this gully. This gully was fenced but no revegetation was undertaken, instead pasture grass was the dominant ground cover. Due to its shorter length only one fixed point was measured for this gully. The data showed a slight increase for measurement 1 between February 2016 and January 2018. There was an overall decrease in gully width at its widest point. Measurement 3 was inconclusive but measurement 4 showed a decrease of 150cm between February 2018 and January 2018. Measurement 5 showed an overall decrease from 190cm to 130cm. The gully depth above the deepest point also showed a decrease, but gully depth below the deepest point showed a 40cm increase in depth.

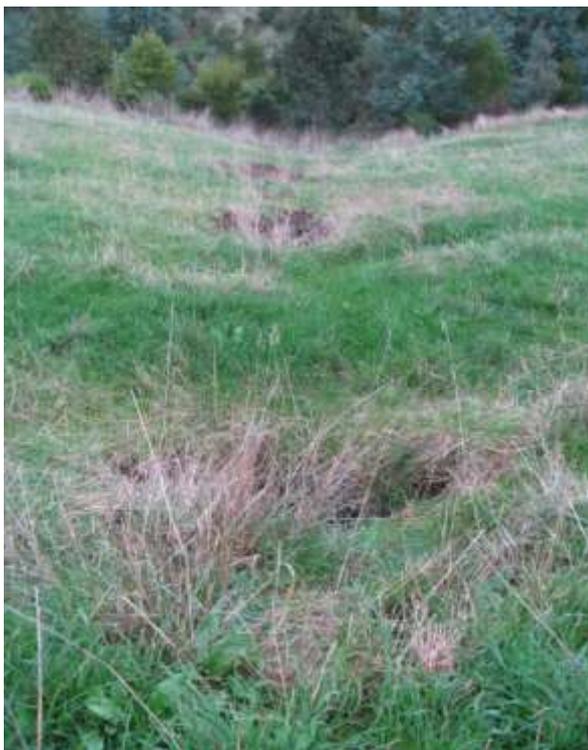
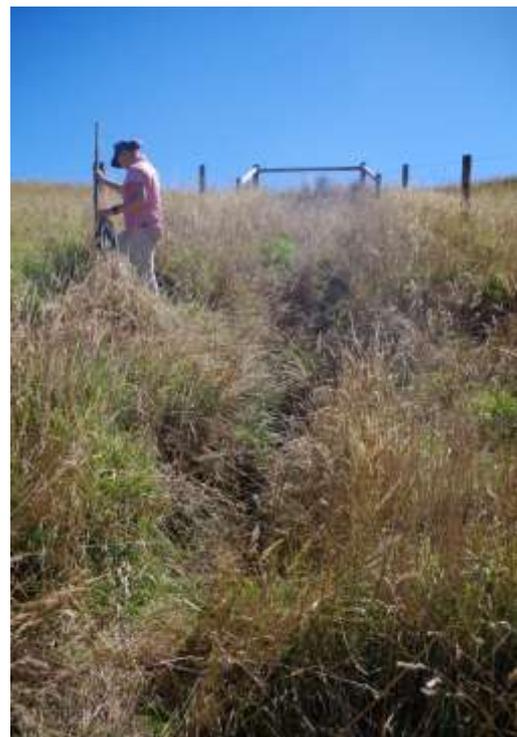
**Photos 4 and 5 - Site B: Before fencing grass control site (May 2014) and post fencing (January 2018)**

**For Site B** the measurement showed a decrease in overall gully width but an increase in depth at the deepest point. Fencing and vegetation establishment would appear to have arrested further widening of the existing gully, however there appears to be continued movement of sub-surface water through the gully from upslope which continues to deepen and lengthen erosion effects along the gully.

**Fenced Site B:** The measurement showed a decrease in overall gully width but an increase in depth at the deepest point. Fencing and allowing shallow rooted grasses to establish would appear to have arrested further widening of the existing gully. However, there appears to be continued movement of sub-surface water through the gully from upslope which continues to deepen and lengthen erosion effects along the gully.

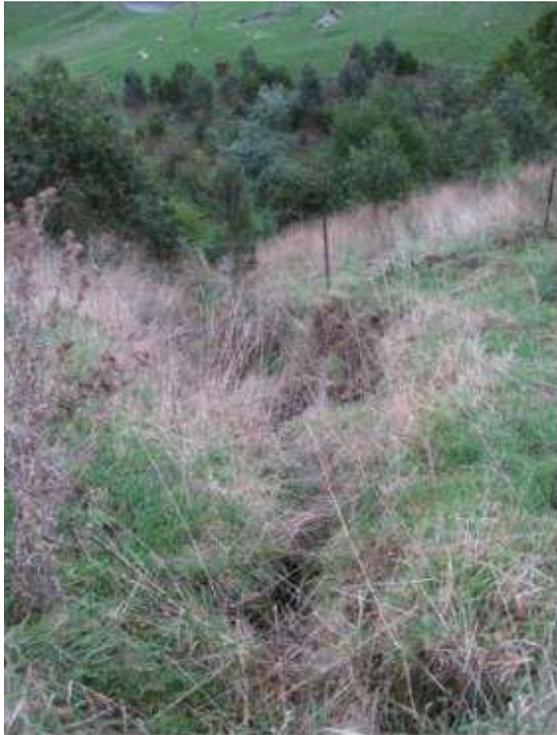
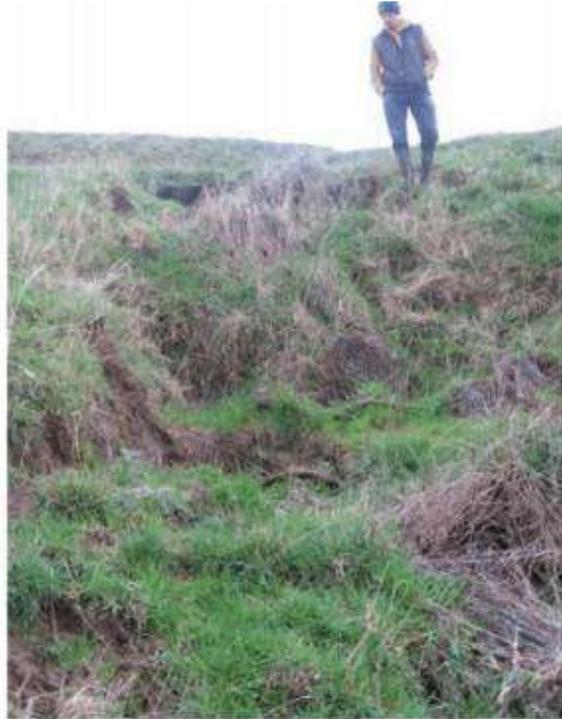
**Photos 6 and 7 - Site C: May 2014: Before fencing and revegetation**

**Site C:** This is another more minor tunnel/gully also located below the internal farm access track that was fenced revegetated with shrubs and ground covers.

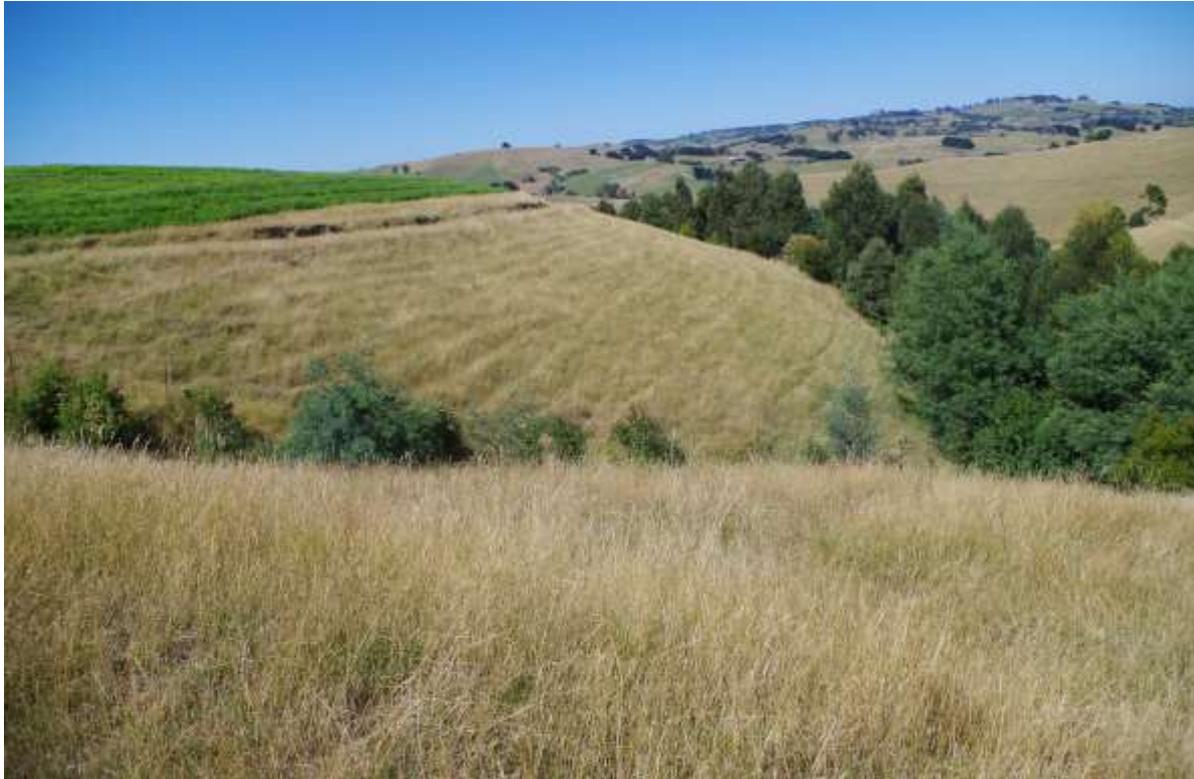
**Site C:** Due to its shorter length only one fixed point was measured for this gully. This gully was fenced and revegetated with mainly shrubs. There was a decrease in the first two measurements between February 2016 and January 2018, however measurement 3 collected in December 2016 seems widely inconsistent. This is possibly due to human error. Measurements 4 and 5 showed an increase in gully width both below the widest point and gully depth at the deepest point. Measurement 6 had decreased to the point where no measurement could be taken. Measurement 7 however showed a decrease in gully depth of 5cm between December 2016 and January 2018.

**Photo 8 - Site C: January 2018 – Post fencing and revegetation**

**For Site C** the measurements showed a decrease in gully width at its widest point, but further widening above and below the widest point. Gully depth below the deepest point showed an increase of 0cm to 150cm perhaps indicating that further tunnel collapse had occurred at this point between February 2016 and December 2016. Results appear to show a similar pattern as that of Site B, where overall gully width has decreased but there has been further erosion in terms of depth and length of area showing evidence of erosion. It would appear to be a good thing that these areas now exclude livestock as they present a clear hazard to livestock and machinery.

**Fenced Site C:** This site has benefited from exclusion fencing and revegetation with shrubs and ground covers. The results appear to show a similar pattern as that of Site B, where overall gully width has decreased but there has been further erosion in terms of depth and length of area showing evidence of erosion. It would appear to a good management decision to exclude these areas as they present a clear hazard to livestock and machinery.

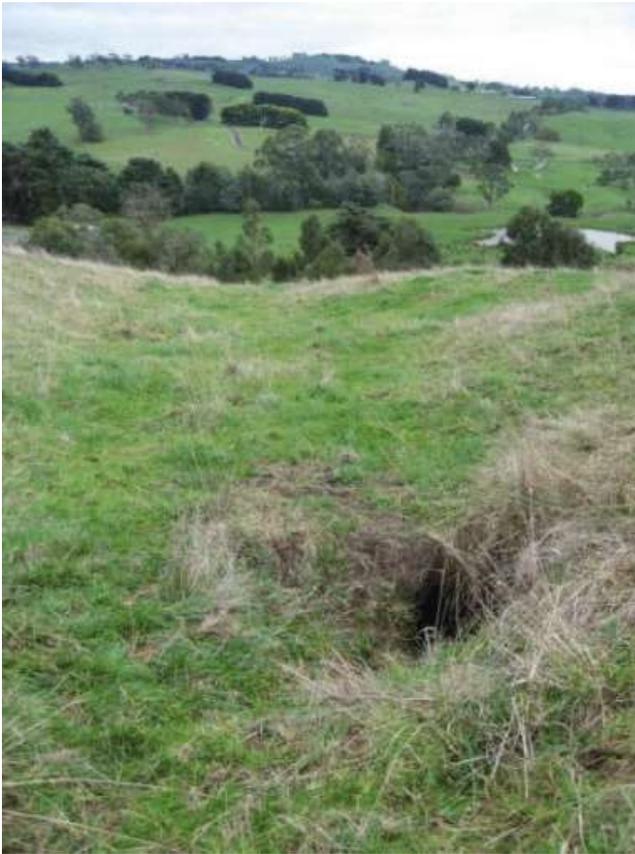
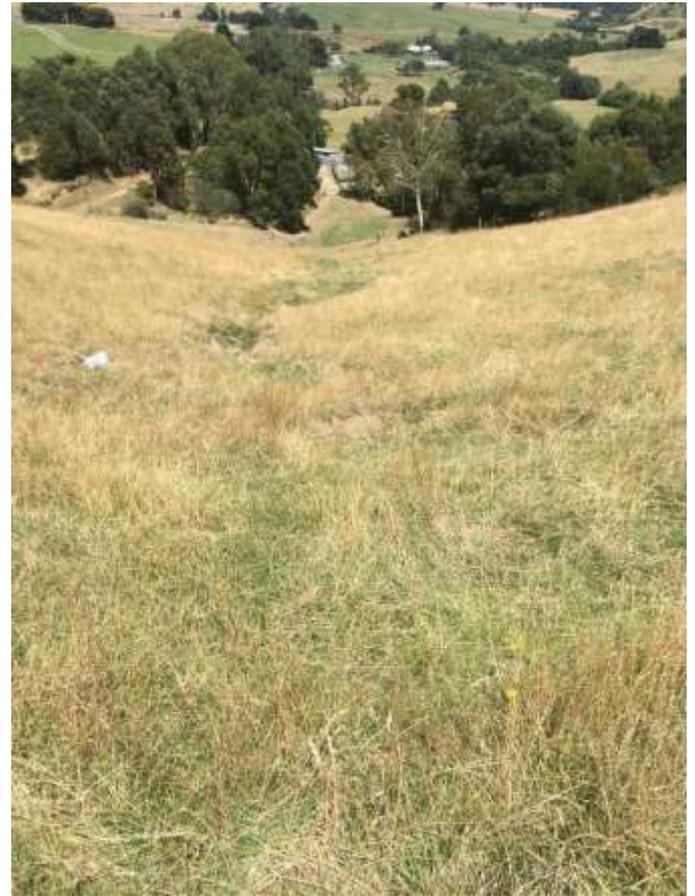
The Magnesium content was high for this site which may have a negative effect on soil structure. Aluminium was also quite high, however, this can be rectified with the addition of lime. The pH is low at 5.09, which is regarded as strongly acidic.

The 2018 sample shows that pH has increased slightly from 5.09 to 5.53. The Calcium content has remained fairly consistent with a slight increase between sample dates. However Aluminium and Magnesium has decreased. This could be due to the mixing action due to excavation activity. The percentage of organic matter has also decreased slightly.

**Photos 9 and 10** - Site 1 at southern end of property: pre-excitation (May 2014) and post excavation (January 2018)

**Excavation Site 1:** Based on observations made in January 2018 the tunnel at Site 1 has since partially reformed and remains a hazard for livestock. The excavation and backfill of this site appears to have been unsuccessful in the short term. Fencing may be the only feasible long term management option for this site.

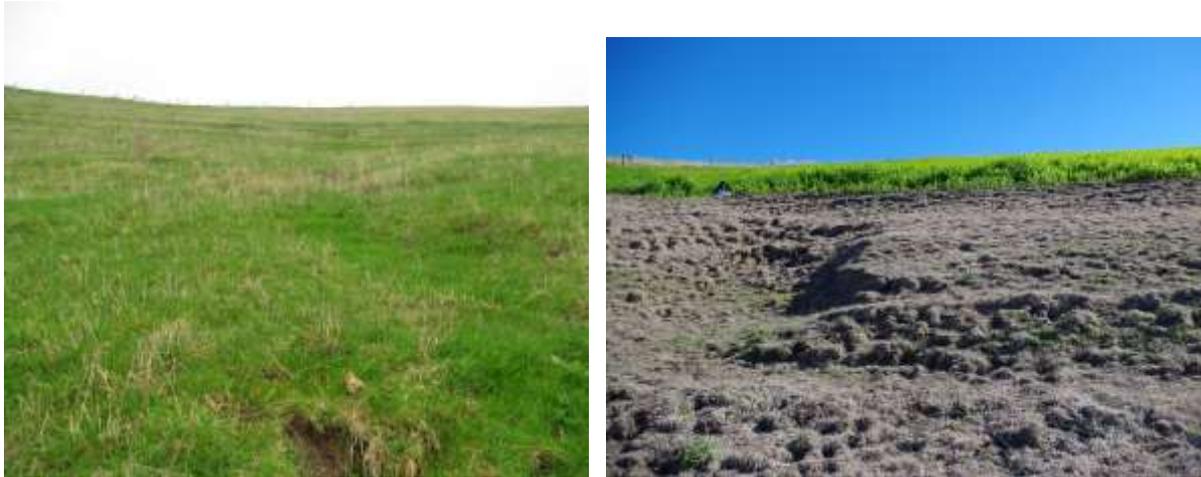
In the trial methodology the landholder intended to add lime to this site to help correct the acidity. However, in a conversation with the landholder on 16/1/18, he indicated that he did not end up applying lime to this site which would explain why there was no response. In the 2018 sample the pH has declined slightly from 5.53 to 5.35. The levels of Phosphorus have almost doubled. It is useful to note the variation in measurement which occurred at these two sites. For example, the initial measures of pH were similar, but the final measure showed one increasing and one decreasing. This highlights the variability in soil measurement. Similar variability is noted with the level of Ammonium, with levels much higher in 2018 sample.

**Photos 11 and 12** - Site 2: Looking upslope (May 2014) pre-excavation and post excavation (January 2018)

There is a large bare area that has not been cropped in the middle of the sites 2 and 3 (see Photo 12). This was a steep area that the seed sowing contractor wasn't comfortable crossing with a tractor and other machinery. This would indicate an area where structural instability remains and in the longer term these tunnels at Sites 2 and 3 may reform

**Excavation Site 2:** Based on observations made in January 2018, the tunnels do not appear to have reformed at Site 2 that were remediated in early autumn 2015. In this respect the management intervention appears to have arrested further development. However, the paddocks that were previously used for grazing have now been sown down to a green fodder crop (possibly Sorghum) making it difficult to see if tunnel erosion is evident.

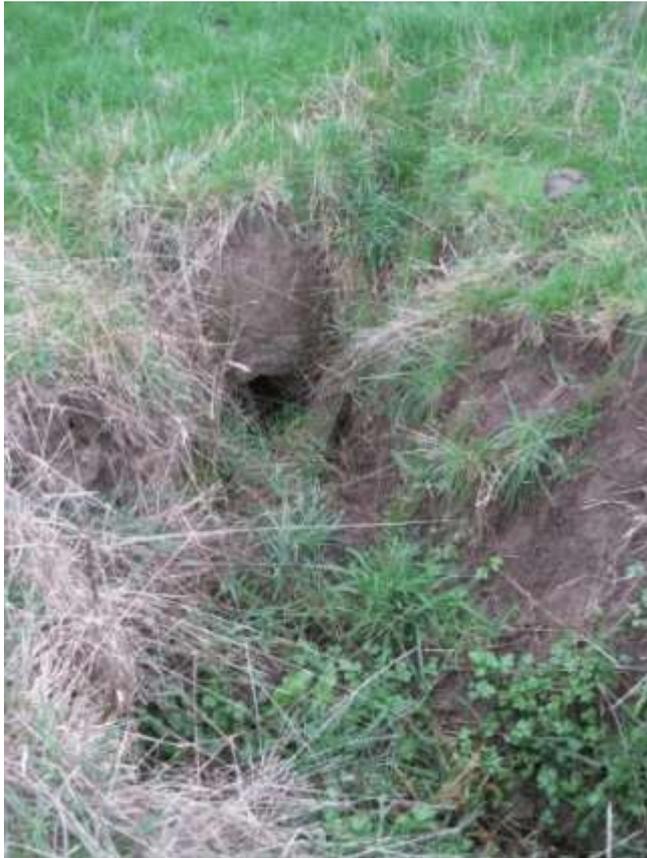
**Photo 13** - Site 3: May 2014: Showing tunnel development

**Site 3:** Rip tunnel and backfill, smooth and treat with gypsum, sow down ryegrass to stabilise. Sites 2 and 3 are in the same paddock and can be compared. Erect temporary fences on all three sites until grass has established. Although this was recommended in the experimental design, Jonathan elected not to do this and laid down hay instead.

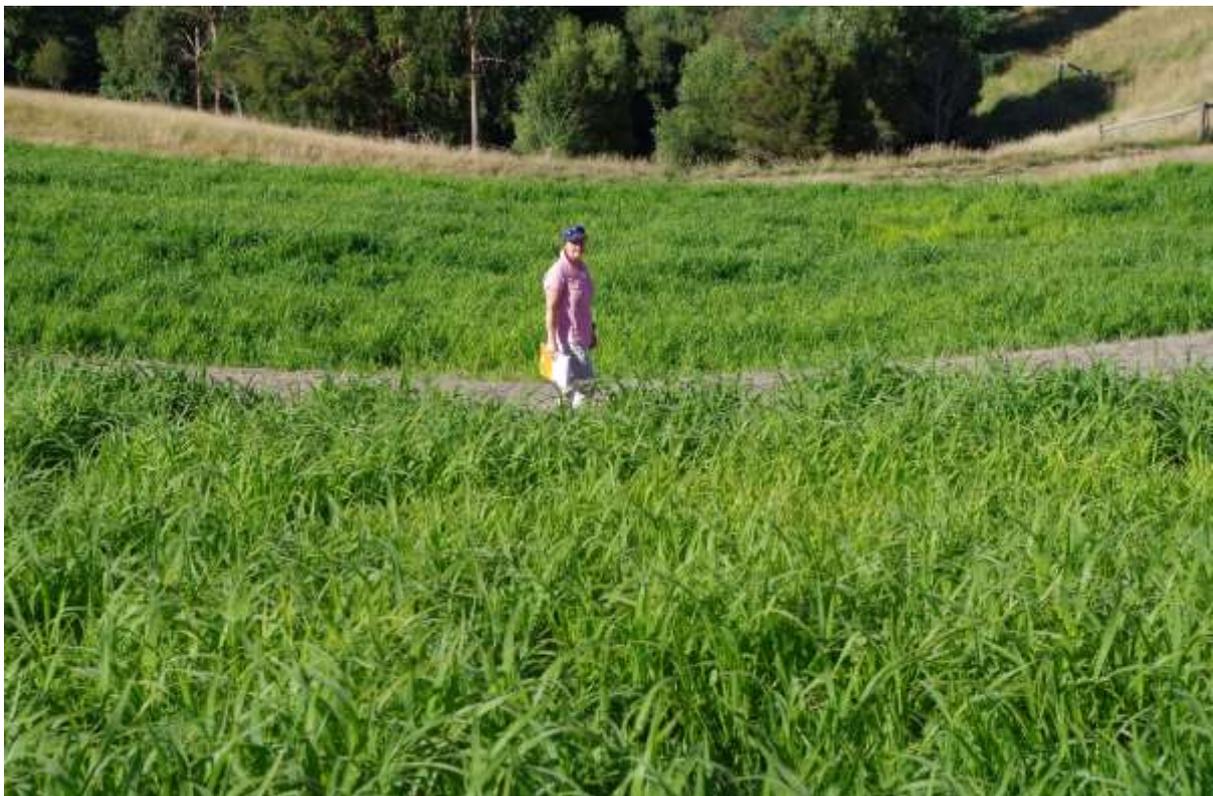
Table 4 shows that despite the addition of lime, no change in pH was measured but the available Calcium has increased. However, the cation exchange rate (CEC%) has remained the same between the 2014 and 2018 sample. There was a significant increase in the amount of Nitrate between the 2014 and 2018 samples which can be attributed to the addition of urea at this site.

**Photo 14** - Site 3: January 2018: Looking downslope: Sorghum crop

**Excavation Site 3:** Based on observations made in January 2018 the tunnels do not appear to have reformed at Site 3, which were remediated at the same time as Site 2.

The addition of lime at Site 3 resulted in no measurable change in pH but the available Calcium has increased. It could be that the application of lime was too small to have a more significant effect or that it hasn't made it down into the plant root zone. The landholder may have to consider increasing the amount of lime added to the soil to bring the pH closer to 6 or 6.5.
